**U.S. Cellular Center
Thomas Wolfe Auditorium
Asheville, North Carolina**

**Acoustic and Structural
Recommendations Report**

10 July 2015

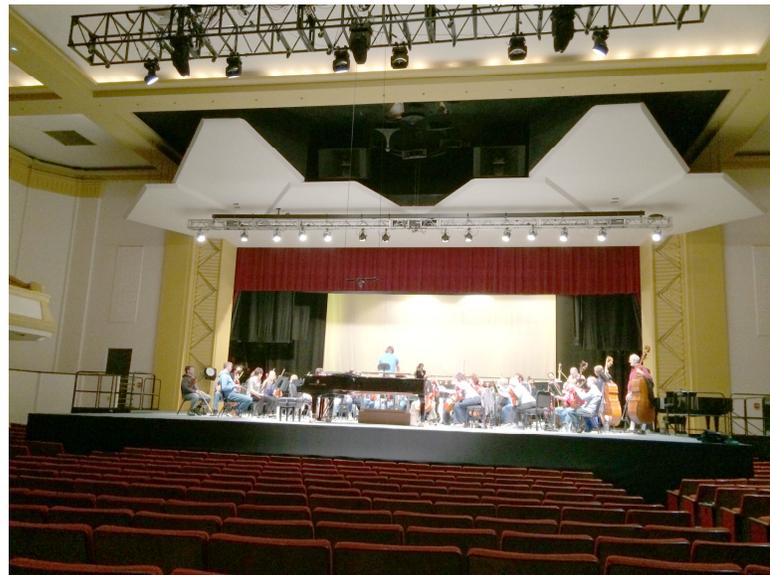
One significant deviation from the original structure within the Auditorium is a forestage proscenium prow and acoustic reflector constructed just in front of the proscenium below the original ceiling construction. We estimate that this was constructed in the 1970's, although no drawings were available showing the proposed construction. From what we can ascertain, this element appears to have been inserted just below the top of the original proscenium opening, and consists of two distinct angled fascia formed with overlapping hexagons (see upper image to the right). The prow/reflector splits as it extends from the proscenium to allow space for loudspeaker clusters. The loudspeakers themselves are quite outdated and appear to no longer be tuned to serve the Auditorium properly, although the systems are in use today primarily for amplified speech presentations. The ceiling coffer located immediately in front of the proscenium was encapsulated by the prow/reflector and loudspeaker housing but appears to remain as seen from the attic above. Black cloth located within the loudspeaker enclosure is currently in poor condition.

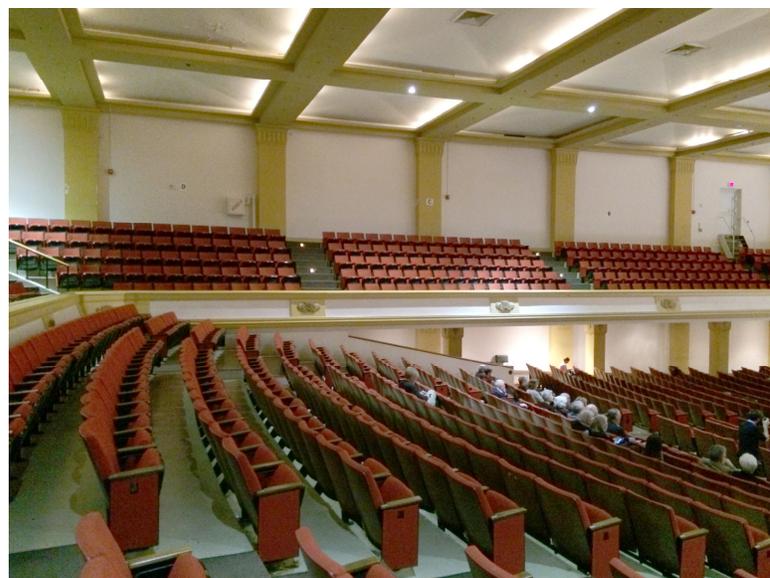
The second major change to the acoustic enclosure of the Auditorium from the original construction is the raking of the main floor seating and the construction of a tiered mezzanine seating area just in front of the balcony (see lower image to the right). We understand that this was added also in the 1970's, although no drawings are available showing its construction or exact geometry. The main floor of the Auditorium, originally flat to accommodate athletic events, was converted to fixed, raked seating when the new Arena was constructed to improve sightlines for music, theater, and spoken word performances. We know that much of the main floor seating area was raked (sloped) from the stage back to the current cross aisle. Behind the cross aisle, the tiered mezzanine seating extends up to the balcony rail. It was not possible to determine the construction of the sloped section, but the underside of the mezzanine can be seen from the mechanical equipment room below.

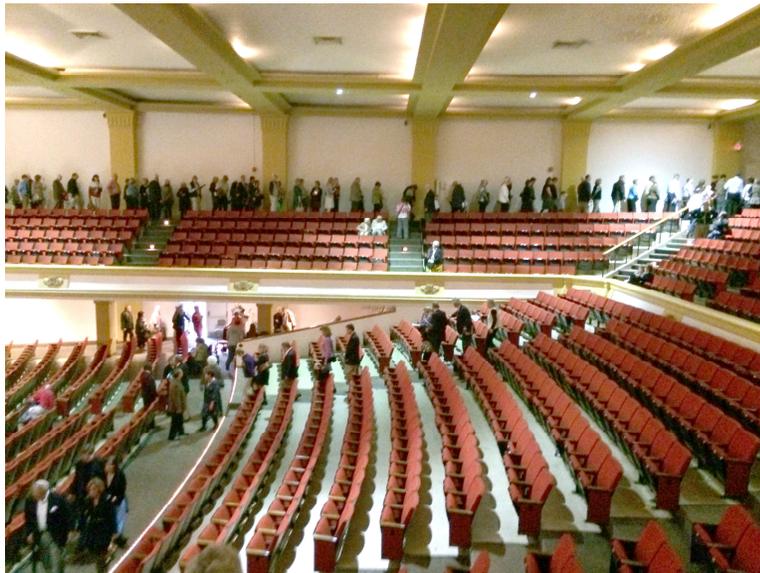
Patrons seated in the balcony and side galleries must exit through the two stair towers located in the back corners of the balcony. These stairs empty into the same inner lobby space used by patrons exiting from the main floor, all must merge and exist through the east doors into the newer outer lobby. The result is that exiting from the balcony and galleries takes much longer than from the main floor. We observed this first hand after the orchestra concert on 22 March, when patrons were lined

up in the aisles at the back of the side galleries after the conclusion of the performance, waiting to exit through the rear stairs. For quite a while after the entire main floor had been cleared, patrons were still lined up across the entire length of the gallery aisles (see image at left).

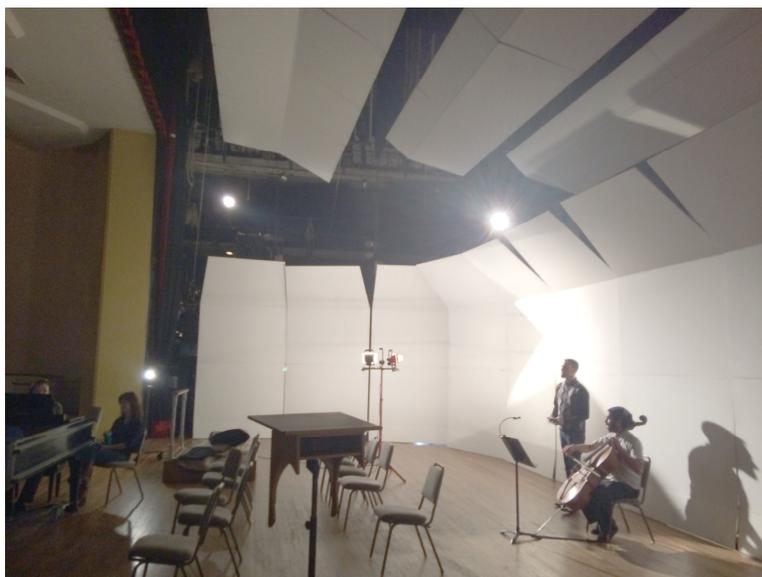
The current orchestra shell (see image to the left) consists of Wenger Legacy portable towers that fold up and are stored in a pocket under the stage right dressing room stack, and ceiling panels that are stored in the stage house when not in use. This is a relatively lightweight system, and it is a standard product that is not optimized or designed specifically for the Auditorium. The tops of the shell towers are typically angled down when the shell is set up. Large gaps around the perimeter of the shell, above the tops of the

shell towers, and between the ceiling panels allow a significant amount of sound to escape into the fly house above. Members of the Orchestra seated within the stage area have noted that they feel as if they are in a separate room from those playing on the stage extension in front of the proscenium.

- A new orchestra shell will be designed that works in tandem with the new forestage reflectors and cheek walls to provide unified shaping from stage to house that creates a single acoustic volume when in use to properly project non-amplified sound into the Auditorium. For initial pricing, it is assumed that 11 towers 25 feet tall and three new stage ceiling panels with integral lighting will be provided. Finish is to be determined but use of some wood is highly recommended.

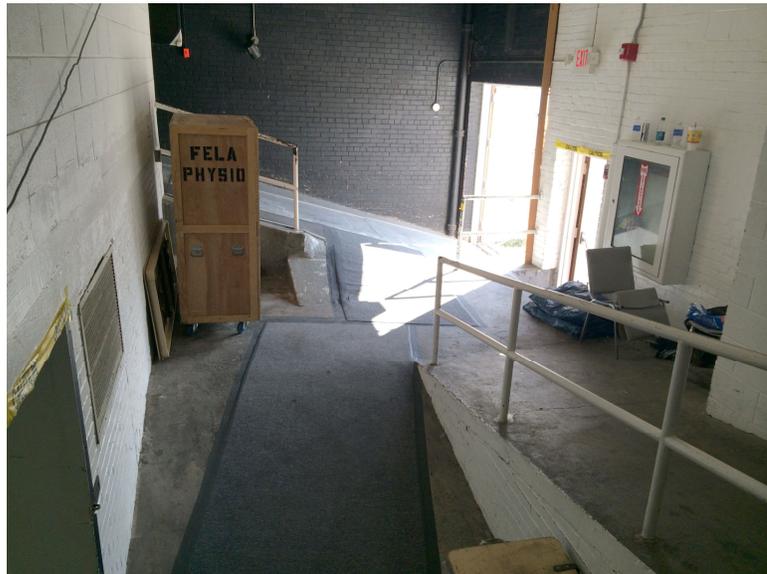
Load-in to the stage from the loading dock serving the Auditorium requires that equipment be brought in by way of a very steep ramp up from the exterior loading dock to stage left (see image at right). This requires up to six men using an improvised rope and pulley system to simultaneously pull and push equipment up the ramp. This is at the very least a major inconvenience for load-in crews and might present a dangerous condition with certain pieces of equipment. Load-in crews must be large to assure reasonable load-in and load-out times due to this condition, increasing production costs for touring events or limiting the number of productions that can occur in the space.

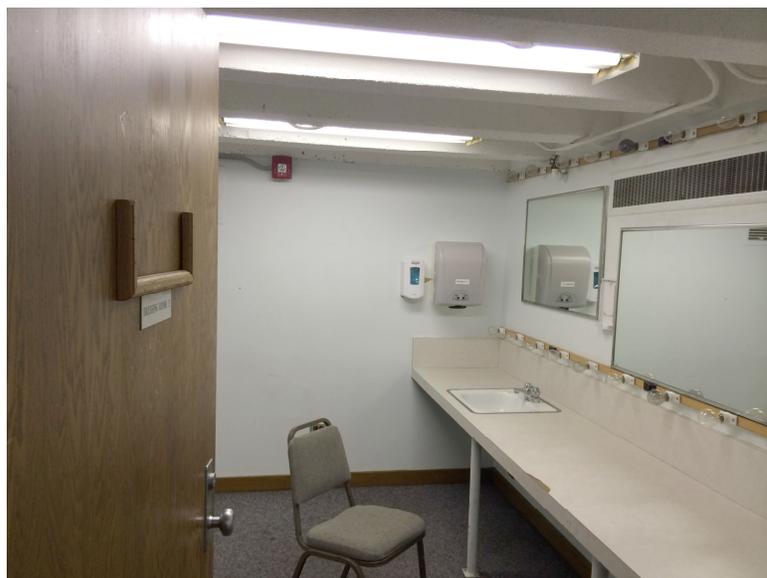
Dressing rooms and a performer green room are located below stage. The dressing room level is not wheelchair accessible. A wheelchair lift does provide access from the audience seating to the stage, but the path to the lift may not be ADA compliant. Finishes, furnishings and toilet/shower facilities are dated in the dressing room area, and there are no large dressing rooms that could serve chorus members for touring shows or for an orchestral performance (see image at right for a typical dressing room). A portion of the below stage space is taken up by a mechanical room, which produces noise that is disruptive in several of the dressing rooms. Due to a lack of a backstage entrance, performers are also

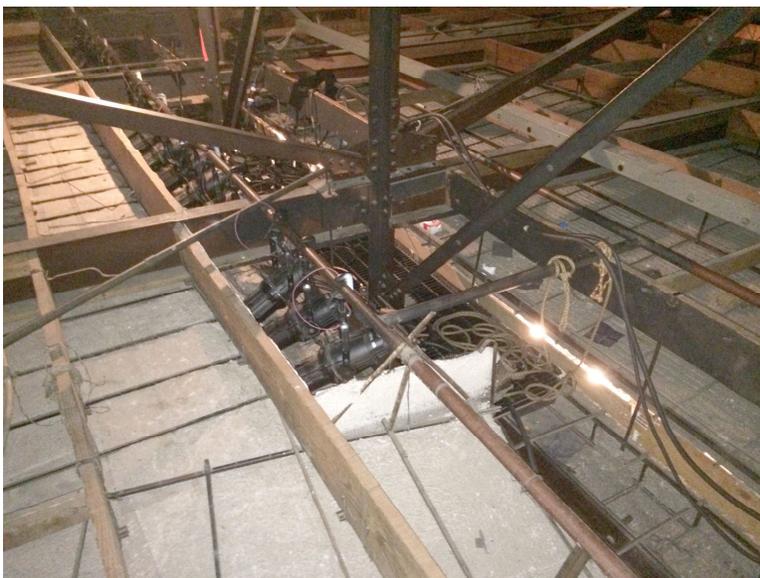
The house lighting system is not adequate to meet requirements for current programming. House lights are non-dimmable, resulting in house lights being shut off completely. This does not allow patrons to read their program as is often required for translation of orchestral choral programs. Additionally, step lights are not provided to guide patrons through a darkened auditorium. General controls for house lighting are not provided at any of the entrances to the auditorium, which is problematic for janitorial staff or technical crews entering or exiting the space. Currently, some lighting units must be left on continuously in

order to provide ample light to reach the control switches on stage, unnecessarily using energy and causing more frequent bulb replacement.

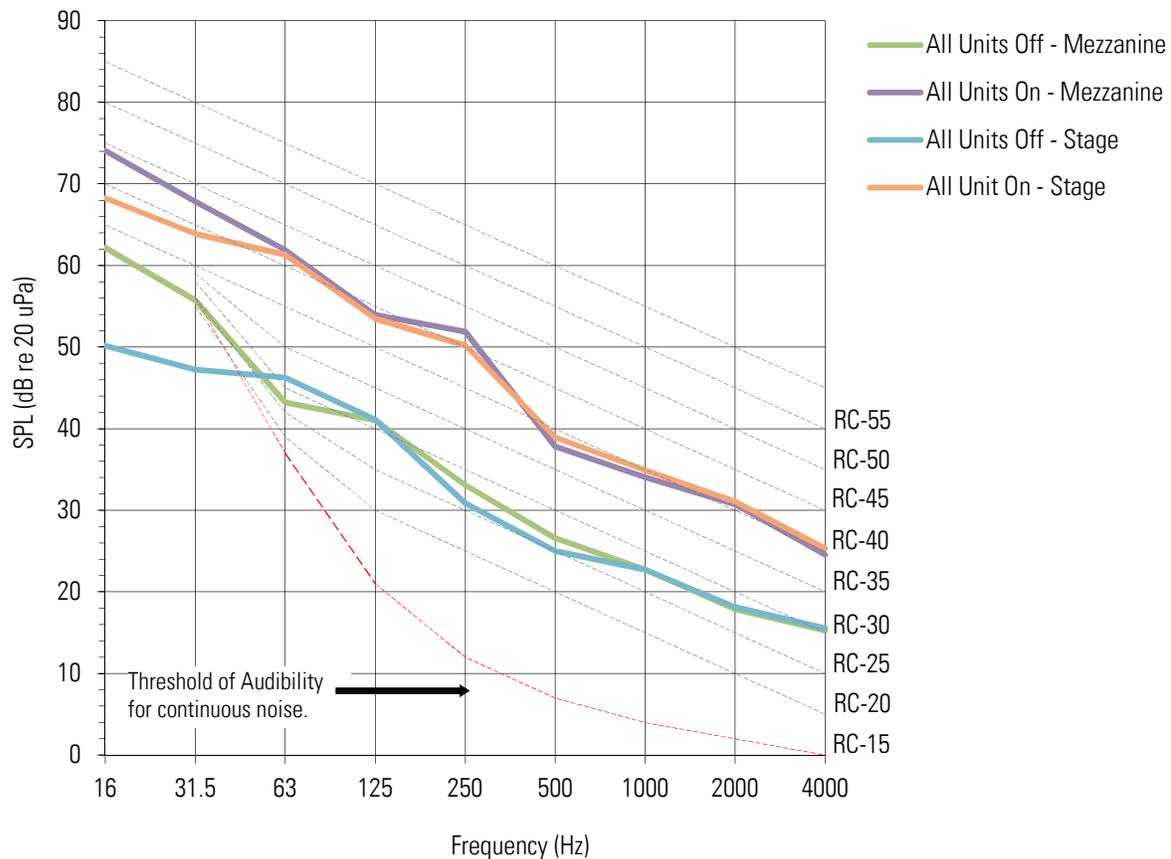
Measured Room Criteria

Measurements taken on the stage were very similar to those taken in the mezzanine seating area. With all the units off, the room has a measured room criteria of RC 22. With all the units on, this increases to RC 35. This significant jump shows how much of an impact the mechanical noise is having during performances. Even low-level mechanical noise can be distracting when cycling on and off during a performance. At the Thomas Wolfe Auditorium, continuous or intermittent mechanical noise at this level is loud enough to impact the patron's experience, making it quite difficult to clearly hear speech or music unless at a loud level. This is especially problematic for non-amplified performances and for audience members seated in the balcony, where they are furthest from the stage and are also in close proximity to the air handlers serving the Auditorium.

When we design a new room with similar programming as the Thomas Wolfe Auditorium, we typically specify that the room achieve an RC 15-20 background noise level. Even without the mechanical units on, the ambient noise of the Auditorium is above this level. A significant amount of mechanical renovation will be required to bring the room criteria down to a level acceptable for modern performances, including new units relocated to areas of the building to reduce sound transfer.

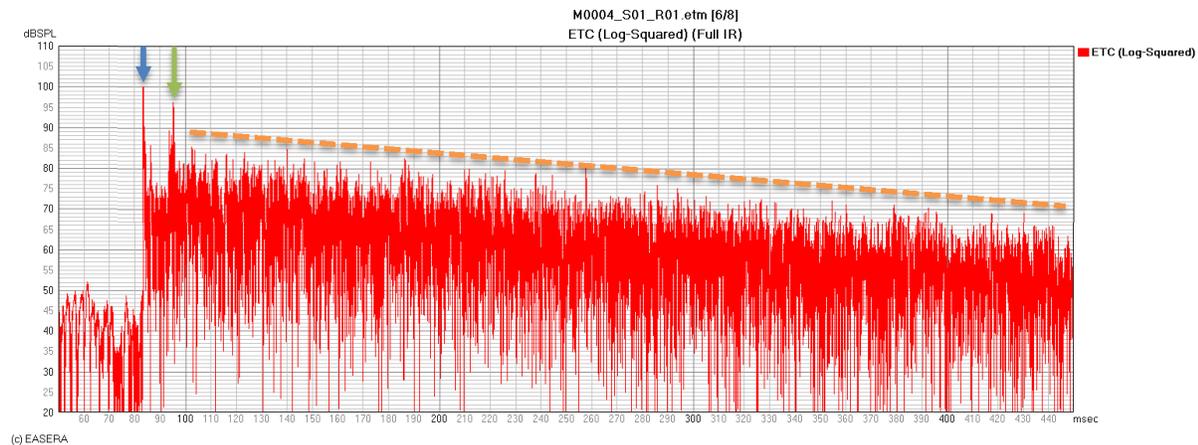
When looking at the impulse response graphs for a receiver located in the mezzanine seating area, it becomes clear why this section is the most popular among patrons. The chart below shows the impulse response of a receiver in the mezzanine with a source located at the Oboe chair in the extended stage configuration. A strong, helpful reflection (indicated by the green arrow) arrives off the ceiling just after the direct sound (indicated by the blue arrow). The decay of the sound (indicated by the orange line) is fairly consistent. There are only a few discernable late reflections, none of which are strong enough to significantly impact the sound quality. Additional support would be beneficial following shortly after the arrival of the reflection off the ceiling to provide greater fullness and impact to the sound, but this response is the best of all locations tested in the Auditorium, as was confirmed by our listening observations as well.

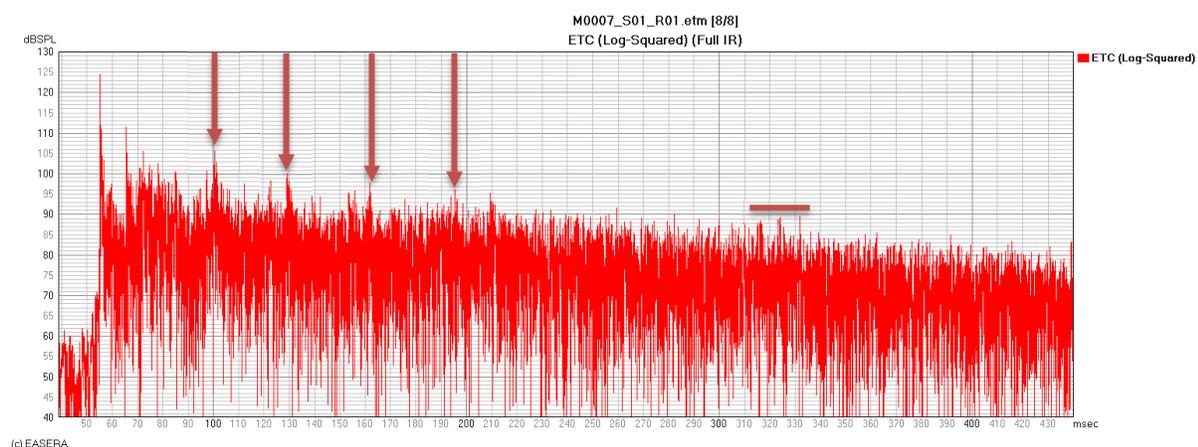
For comparison, the following graph is taken from a test conducted with the typical stage configuration, with a source at 1st Violin Stand 2 and a receiver in Section B of the house left side gallery. This graph clearly shows strong, repeating reflections (indicated by the red arrows), most of which arrive outside of 50 milliseconds after the direct sound, demonstrating the presence of flutter between the side walls of the house. Flutter in this location not only muddies the sound, but also gives the sound the harsh quality that we experienced here. This location also receives a strong cluster of late reflections (shown under the red line), illustrating the echo coming from the rear wall of the Auditorium that was audible in our listening.

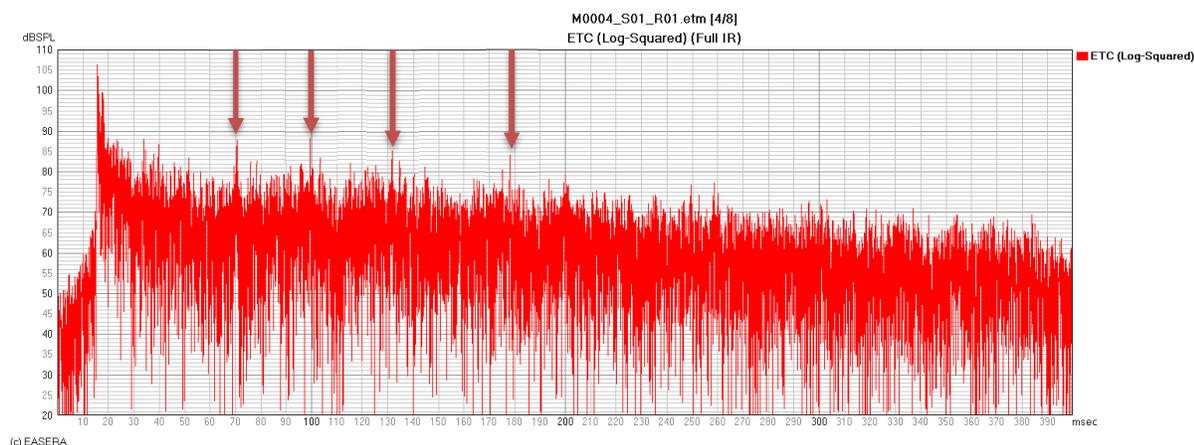
This same effect is demonstrated on the next chart, which was measured during the extended stage configuration testing, with a source at the Oboe chair and a receiver at Viola 4th Stand. The viola section was seated just in front of the proscenium between the two parallel side walls. Flutter in this location was the cause of the confusing nature of the sound experienced by members of the orchestra while performing on the stage extension.

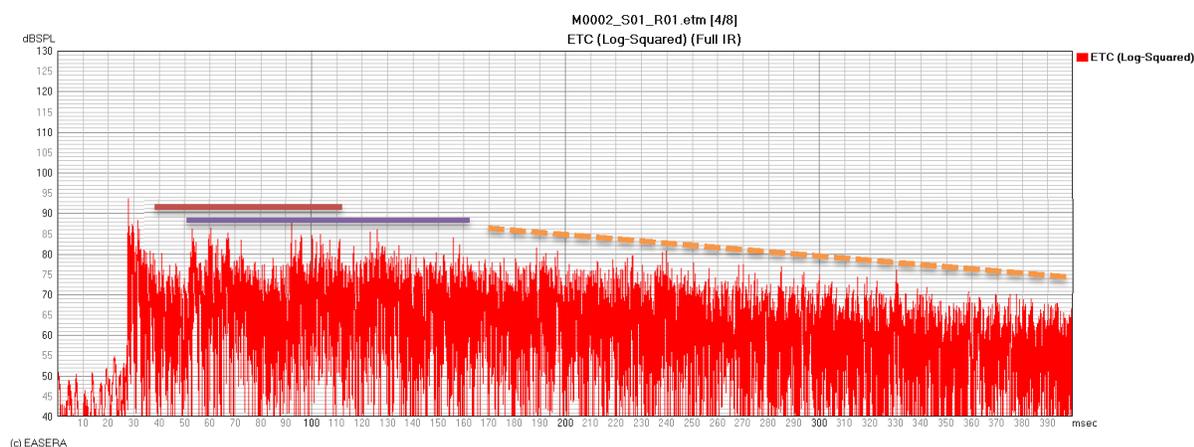
Testing in the extended stage configuration also confirmed the concern we had in first seeing the significant gap in the current forestage reflector. The gap in the center of the reflector, created to house the loudspeakers, causes a corresponding gap in sound coverage both on stage and to the front of the main level of seating. The following graph shows a test measured with a source at 1st Violin 2nd Stand and a receiver at Viola 4th Stand, located on opposite sides of the stage from each other. There are no helpful early reflections to the receiver (in the area under the red bar on the graph) similar to what was illustrated previously for the Mezzanine seating level because of the gap in the reflector. Furthermore, the response level is generally flat for the first 150 milliseconds (in the area under the purple bar) before the reverberation decay begins to take shape (indicated by the orange dashed line). This points toward an indistinct quality to the sound that masks or confuses the direct sound occurring just before this later sound energy.

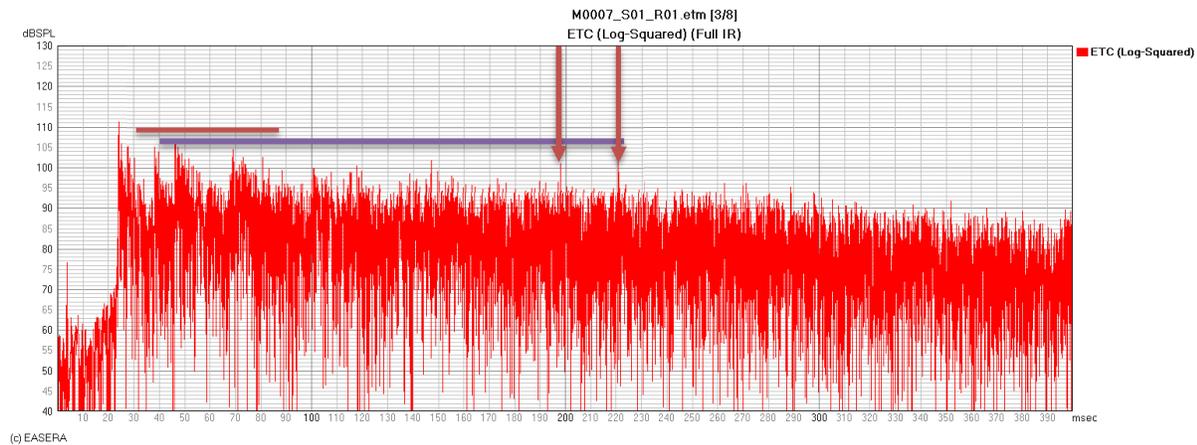
The support for cross-ensemble communication is not much better in the typical stage configuration with the current shell. The next graph shows a test in that configuration with a source located at 1st Violin 2nd Stand and a receiver at the Horn chair. The sound at this location suffers from poor support due to indistinct early reflections (in the area under the red line on the graph) due to the large gaps in the ceiling elements of the forestage reflector and orchestra shell ceiling panels. The prolonged pattern of nearly level sound energy is similarly problematic at this location (in the area under the purple bar). This receiver location also shows strong echoes (indicated by the red arrows) that are likely coming off the doors at the rear of the main floor of the Auditorium. These echoes, combined with the lack of early supportive reflections, clearly show why the cellist performing as part of the piano quartet had a hard time keeping in sync with his fellow players while seated upstage.

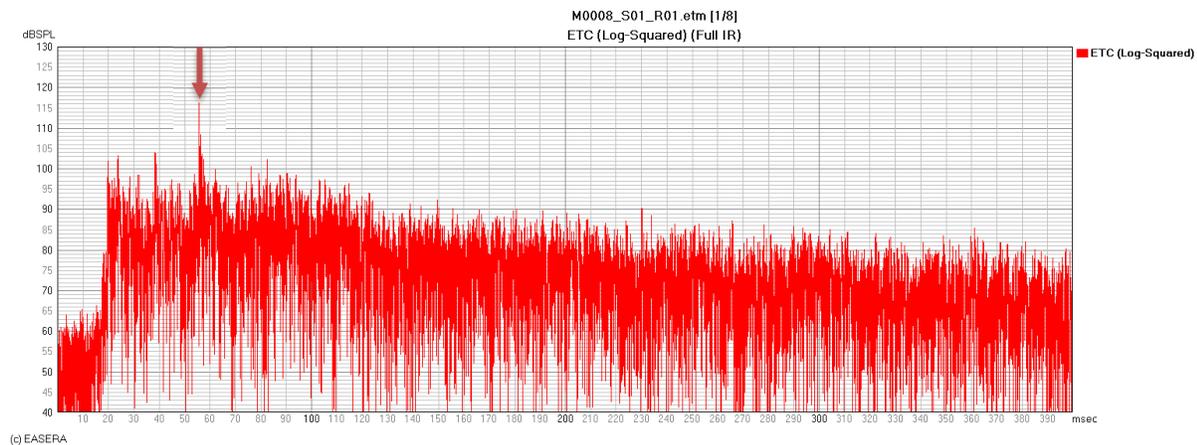
Echoes are quite strong for performers seated in front of the proscenium in the typical stage configuration. Below is the graph showing a source at the Oboe chair and a receiver at the Concert Master chair. An echo stronger than even the direct sound (indicated by the red arrow) shows focused sound energy that would make it impossible to acoustically distinguish the initial sound and this strong reflection. Ensemble timing in this case could only occur with players carefully watching the conductor's baton.
