Thomas Wolfe Auditorium
U.S. CELLULAR CENTER
Ashville, North Carolina

Report of Impact to Structural due to Recommended Renovations

Prepared for
Threshold Acoustics

July 10, 2015

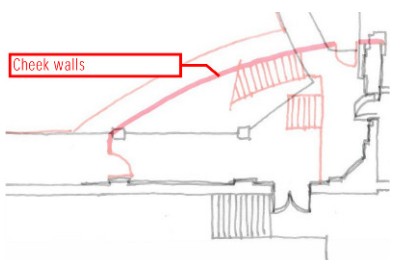
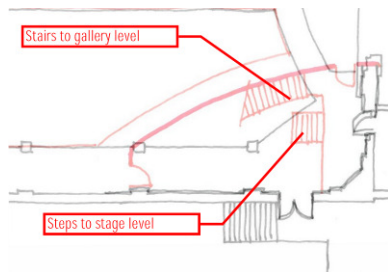
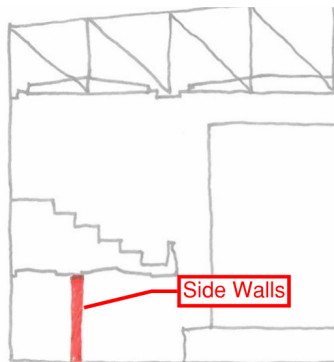
- Construct curved cheek walls on both sides of the auditorium immediately in front of the proscenium opening from orchestra seating level to the underside of the roof deck. Assume metal framing with three layers of drywall on the outer side (facing the auditorium). Construct around the existing side gallery structure. The installation of the cheek walls is obviously a high acoustical value and is a necessary modification. The construction must be as light weight as possible so that a relatively small amount of mass credit is used from that accumulated above. It must also be done in a symmetrical manner as noted. It is expected that a grid of HSS steel shapes will be required to create support for the metal studs and dry wall construction. Based on similar walls the vertical HSS sections are likely to be HSS 20x8 sections at 10 ft

on centers. It is a moderate use of any mass credits but must be carefully executed. *For estimating assume metal stud framing with drywall attached the existing structure. Allow for 16 tons of HSS 20x8 sections and 8 tons for curved horizontal support members. Allow an additional 6 tons total of small sized complicated steel at the ceiling for kickers to the existing structure and roof. And lastly add 8 tons of miscellaneous steel to be added below the floor to locally reinforce the support members.*

Work in this section includes construction of acoustically supportive walls adjacent to the stage just in front of the proscenium, known as "cheek walls." Refer to Sketches 04 and 05.

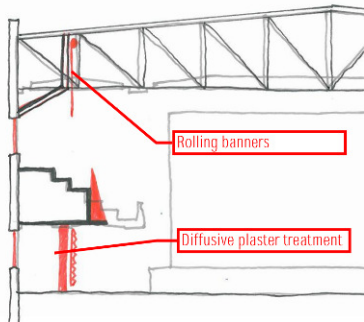
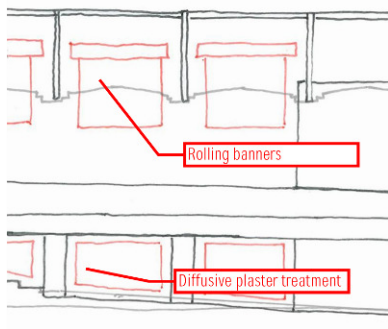
- *Install permanent diffusive elements along the side walls of the orchestra level seating and the upper galleries. Assume construction of pre-fabricated plaster panels that will be installed on the existing walls and finished. Note that if the plan option for the orchestra level seating with new walls constructed along the column line, the diffusion in these locations will be on the new wall instead of the existing wall. This is of high value and low additional cost if already combined with the side gallery walls noted above. The additional impact to structure is null. *For estimating other than the primary construction there is no added structural cost associated with these modifications.**

- *Install mechanically-operated rolling banners within each structural bay at the upper corners of the room on both sides. This is a high value low cost item with almost null impact to structure if combined with other modifications including the ceilings, MEP, and soffit enclosures. There would be minimal to no use of mass credits. *For estimating other than the primary construction there is no added structural cost associated with these modifications**

Work in this section includes elements placed within the space to improve the acoustic environment for both amplified and nonamplified performances. Refer to Sketch 07.

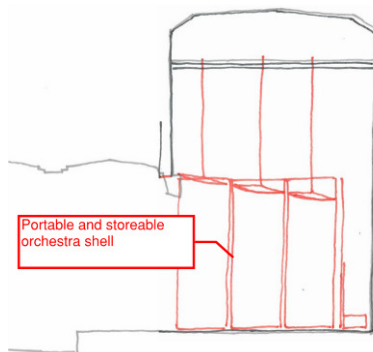
- *Purchase a new orchestra shell designed specifically for the stage and house. Assume 11 towers at 25 feet tall, plus three ceiling panels that will be suspended from the rigging system. The shell like the stage extensions are high value and low cost as compared to permanent solutions. The shell wall system should be custom made to work efficiently with the other modifications such as the cheek walls, proscenium modifications, stage extensions and etc. As this is a relatively light temporary condition, this will have a null effect on the structural load capacity and the mass would not be tracked as it is part of a normal variable stage load and because it is not fixed to the primary structure. For estimating there is no added structural cost associated with this modifications except that which would be required to create a storage space.*

Work in the section involves the purchase of a new orchestra shell on stage. Refer to Sketch 09.

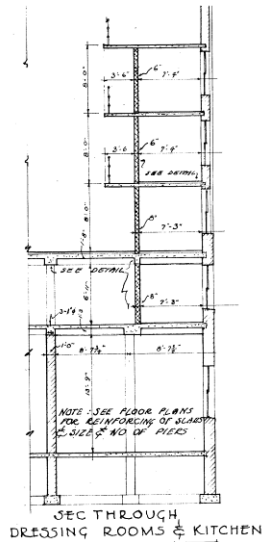
Work in this section involves replacement and expansion of the rigging infrastructure. Refer to Sketch 10.

- *Demolish three levels of existing dressing rooms and the fly loft located stage right. This modification is of high value, deposits mass in the bank, but would require that the new fly loft below be stiff enough to replace the combined effects of the dressing room*

floors. By comparison to the other side it is likely that this is governed by the amount of window area. *For estimating there is no added structural cost associated with this modification.*

- Construct a new fly loft located stage right midway up the height of the stage house (positioned to work with a doublepurchase system) to maximize the wing space available under the loft. Install a spiral stair in the northwest corner of the stage to connect stage level to the new fly loft and the new grid. This modification is a high value and moderate cost but would need to respond to the structural impact of removing the dressing room floors. *For estimating include approximately 20 tons of structural steel for this modification in addition to all of the specialty members..*

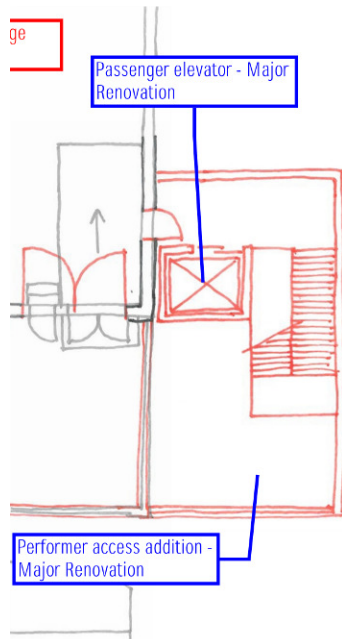
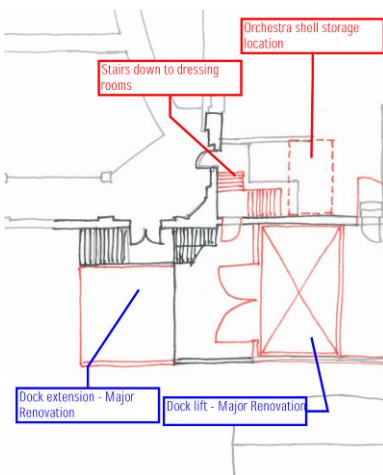
Work in this section includes improvements to the load-in and crew/performer access to the loading dock, stage, and dressing rooms. Refer to Sketches 12, 13, and 14.

- *Construct an addition on the southeast corner of the stage to house. Assume the structure underneath the new platform lift and loading dock will be exposed steel pylons. Include the following access-related items:*
 - *At ground level, a performer's entrance and security check point (when required for shows) with access to a passenger elevator and stairs connecting to the loading*

dock, dressing rooms, and stairs. See combined comment below.

- *At dressing room level, access to the passenger elevator and stairs. See combined comment below.*
- *At loading dock/stage levels, a large platform lift connecting the loading dock to the stage level, new large loading doors into the stage, and access to the passenger elevator and stairs. See combined comment below.*

- *The following is a combined comment on the above proposed modifications which would complete the basic needs for the functioning of the back of house and stage. For most of these modifications there would be little to null impact to the base structure as most of the work would involve standalone independent structures. The cost would be high as an elevator would be involved but the structure would (could) be very simple..*

Based on the site visit the best value would be obtained if these structures were all new. Adding onto the existing loading dock would likely involve workarounds and strengthening of what concrete, steel and masonry in-fill. The entire structure could be made of composite steel and braced frames for quick erection. Infill of the steep ramp to create a flat access is a high value as witnessed during the load-in and load-out of the two venues that were observed. **It is the writer's opinion that the loading dock and ramp to the stage should be updated irrespective of the direction of the future work.** *For estimating assume that this work would be equivalent to the addition of a multistory enclosed elevator and stair tower. Allow for approximately 20 psf of moderately detail complicated structural steel for the building. This would amount to almost 16 tons for the addition. Assume normal steel braced frames with steel beams, 3" 20 gage metal deck, composite studs and 4 1/2 inches of concrete topping. Assume spread footings for*

the foundations. Assume roof deck with rigid insulation. The façade will be brick with CMU backup. An alternative would be metal stud backup while a third would use metal stud and metal panel.

For estimating assume that the loading docks will use galvanized steel braced frames (approximately 30 tons) with concrete slabs. An alternative would be a CIP concrete footings, columns, and floors. Assume (10) 2'x2' reinforced concrete columns on spread footings with an 8" thick concrete slab and 24"x24" beams on all sides and 10 feet on centers max. Total reinforcing for a multilevel loading dock of approximately 20'x 80' is 20 tons of galvanized rebar.

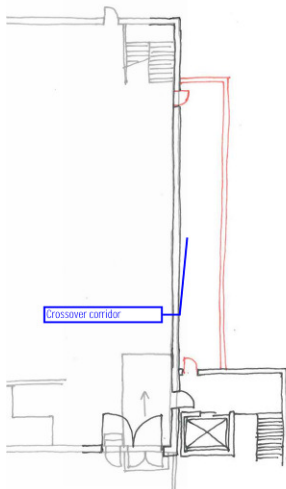
Work in this section involves the construction of a stage crossover for performers to use during performances. This work assumes the option for the loading dock addition (described above) has been selected. Refer to Sketch 17.

Install a new crossover corridor behind the stage. Construct with framed walls with exterior masonry cladding. This modification would be a high value and relatively low cost depending on the ability to install foundations below. If a standalone structure it would have null impact to the base structure. For estimating assume that this work would be equivalent to the addition of a single story covered enclosed. Allow for 10 tons of simply detailed structural steel for the building. Assume normal steel braced frames with steel beams, 3" 20 gage metal deck, composite studs and 4 1/2 inches of concrete topping. Assume spread footings for

the foundations. Assume roof deck with rigid insulation. The façade will be brick with CMU backup. An alternative would be metal stud backup while a third would use metal stud and metal panel.
